Manhole Inspection Summary

Manhole # S19CC1013MH

Location Address: **2140 DRUID PARK DR**

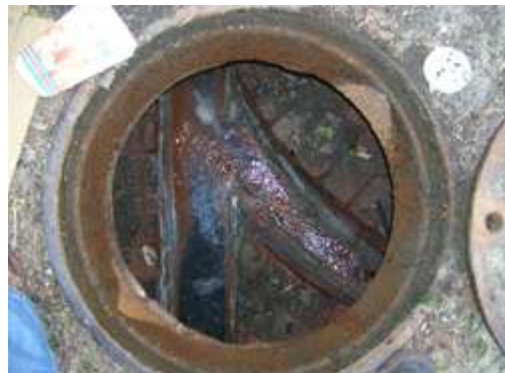
Top View

Bench debris.

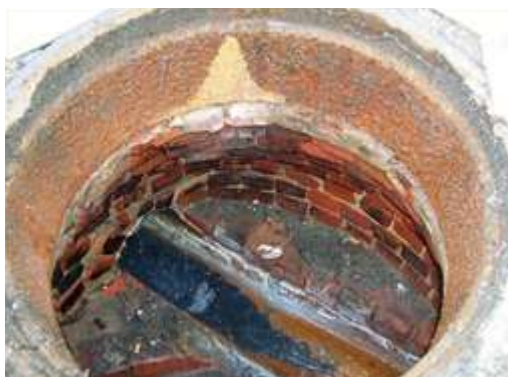
Defect

Frame leaks. Frame leaks. Adjustment deterioration and infiltration. Corbel and Barrel infiltration - other side.

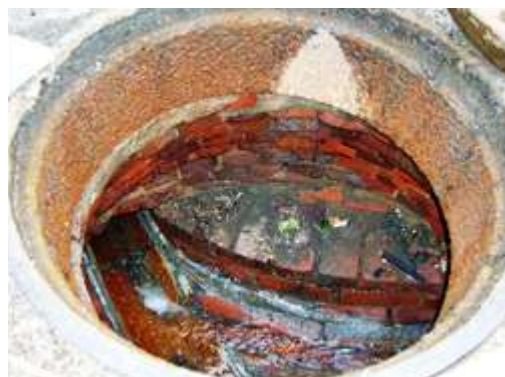
Defect

Frame leaks. Frame leaks. Adjustment deterioration and infiltration. Corbel and Barrel infiltration.

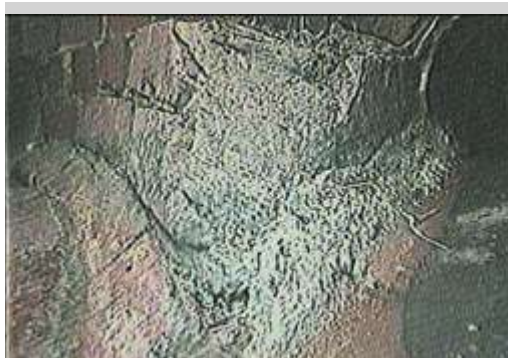
Defect

Bench and Channel deterioration.

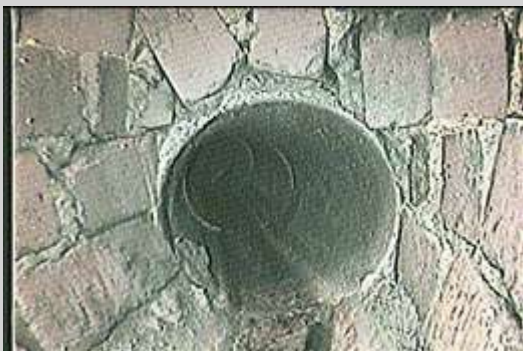
8 in. Circular Gravity Sewer Pipe In @ 4 O'Clock

Barrel deterioration and infiltration. Channel deterioration.

Infiltration: **Evidence** Pipe Seal Cond: **Cracked**

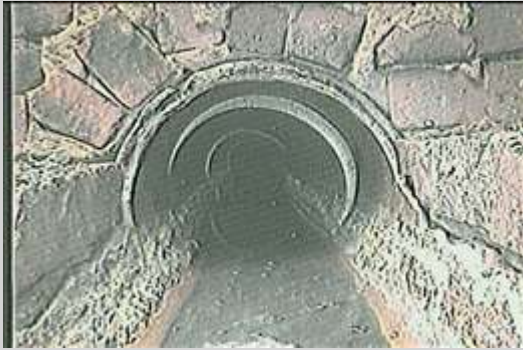
Pipe In @ 6 O'Clock

Channel cracks.

Deposits: ☐ None ☒ **Mud** ☐ Sludge ☒ **Debris** ☒ **Grease**
